Title of Report: Deep River Restoration Survey Area Addendum Archaeological Survey Report

Deep River Restoration Survey Area Addendum Archaeological Survey Report

Prepared for
Columbia River Estuary Study Taskforce

HEG Contract No. 25-096

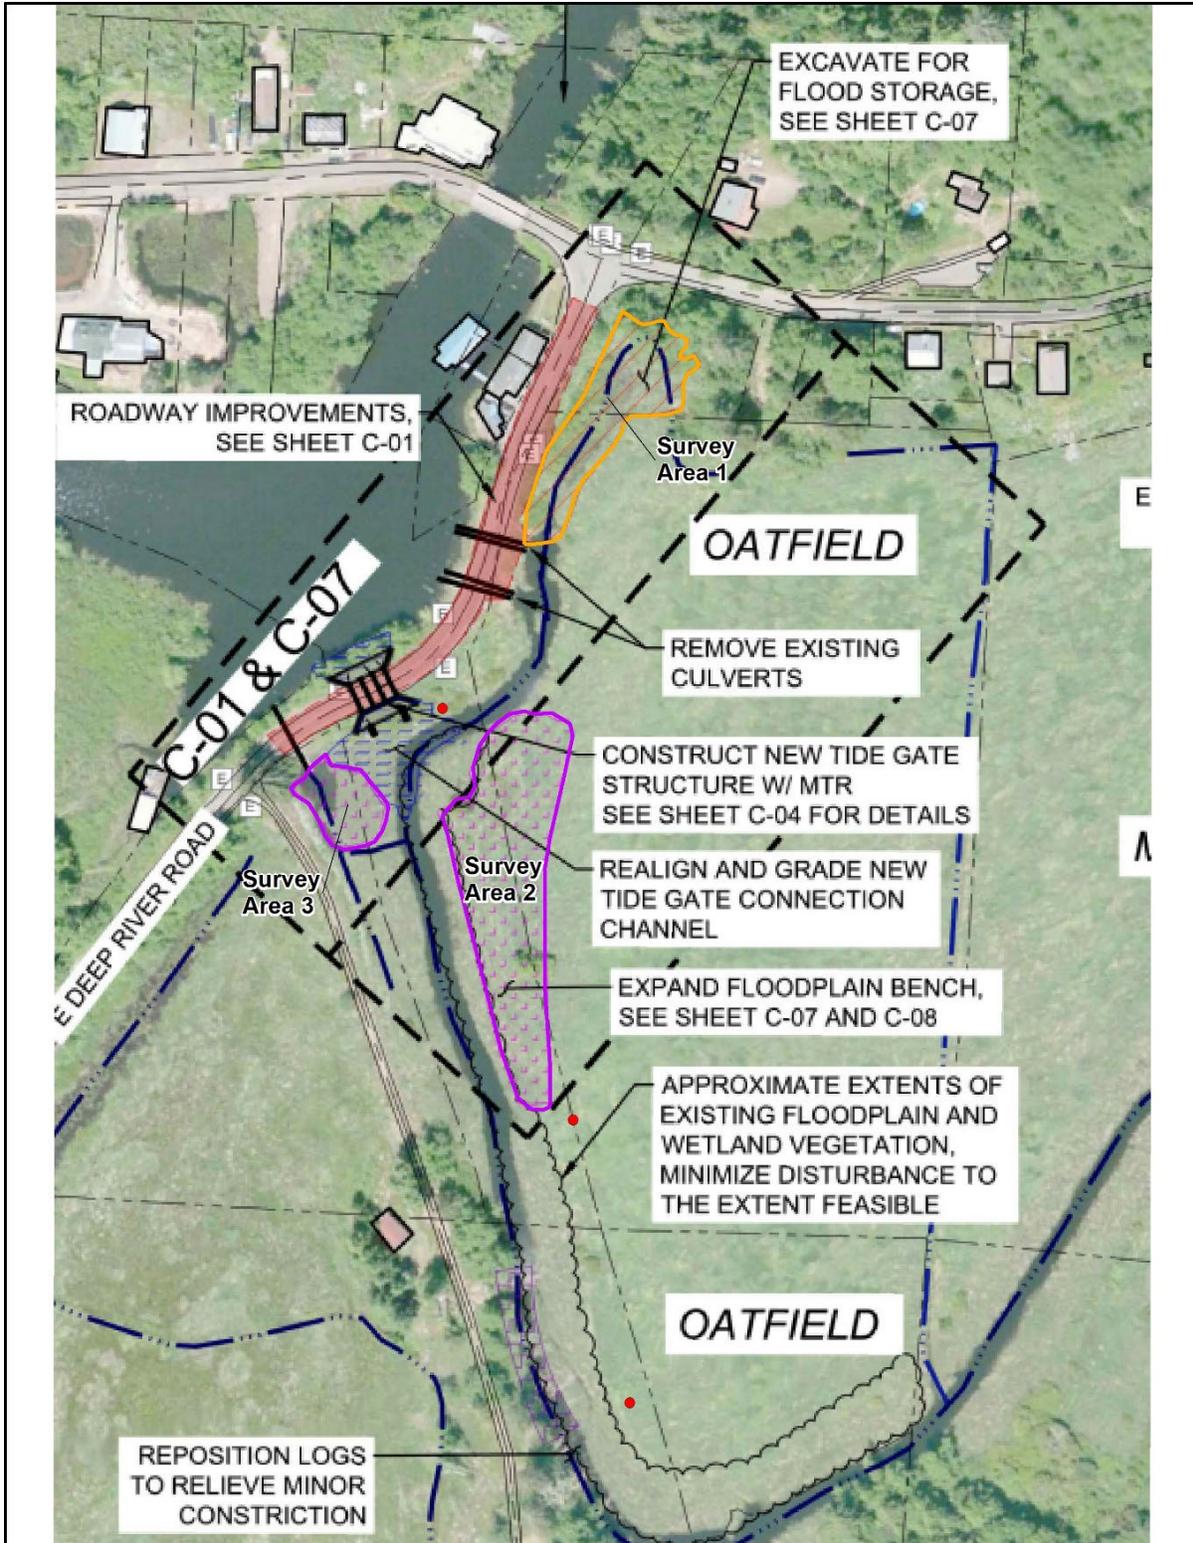
Figure 3. CREST provided plans for Survey Areas 1, 2 and 3.

Survey Area 1, depicted in the CREST provided project plans, “Excavate for Flood Storage” highlighted in orange, is located in the northern portion of the floodplain, below E. and W. Deep River Road (Figures 2 and 3). Survey Area 1 is planned to undergo floodplain lowering by surface layer excavation with a max 2 feet (ft.) excavation depth. This area has been reported to be inundated from failed culverts for some time (Patterson 2024). There was no exposed soil or elevated land to examine within Survey Area 1 (Figures 4-6).

Survey Area 2, depicted in the CREST provided project plans, “Expand Floodplain Bench” highlighted in purple is located in the central western portion of the floodplain (Figures 2 and 3). Survey Area 2 will undergo floodplain lowering through benching and expansion excavation, with a max depth of 5 ft., but more commonly 1-3 ft. Harris Environmental previously excavated shovel test pit (STP) 36, during the initial survey in 2024 (Figure 16). STP 36 contained truncated, mottled clayey soils just below the surface (Patterson 2024).

Survey Area 3, depicted in the CREST provided project plans, highlighted in purple is located southwest of the tide gate installation off E. Deep River Road (Figures 2 and 3). Survey Area 3 underwent a previous subsurface investigation, STP #13, in the 2024 (Figure 16). STP 13 revealed fill material from the original tide gate and culvert installation as well as more impounded soils

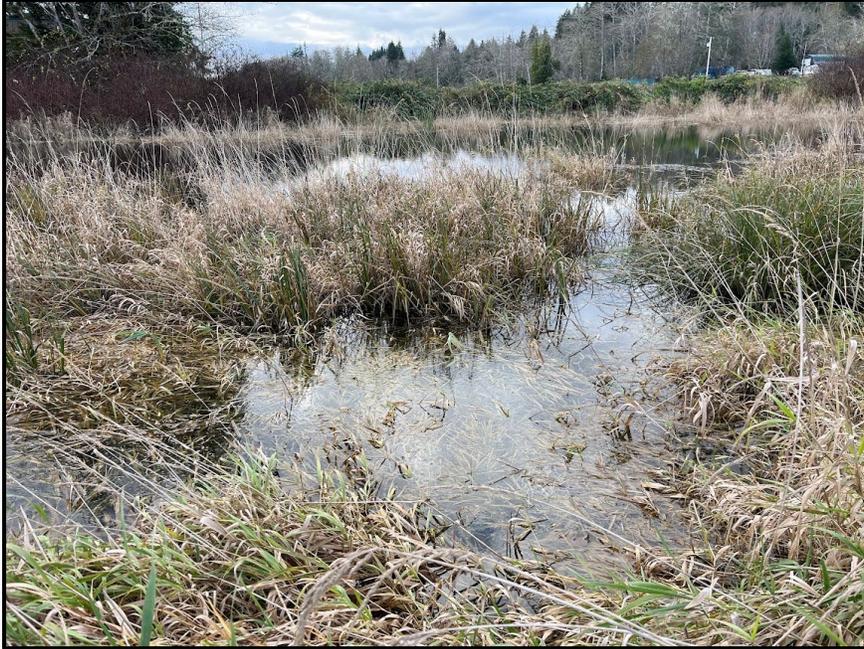
Figure 9. Overview of Survey Area 2 showing deeper water depths on the western boundary, facing west-southwest.

At the time of the site visit, addendum Survey Area 2 held waters approximately 1 ft. one foot deep at low tide (Figure 7), and at high tide water level increased to approximately 2-2.5 3 ft. deep (Figure 8). The western border of Survey Area 2 drops off into deeper water depths (Figure 10). The only elevated land in Survey Area 2 is on either side of a lone Box Elder Maple (*Sapindaceae*) tree (Figures 10-12).

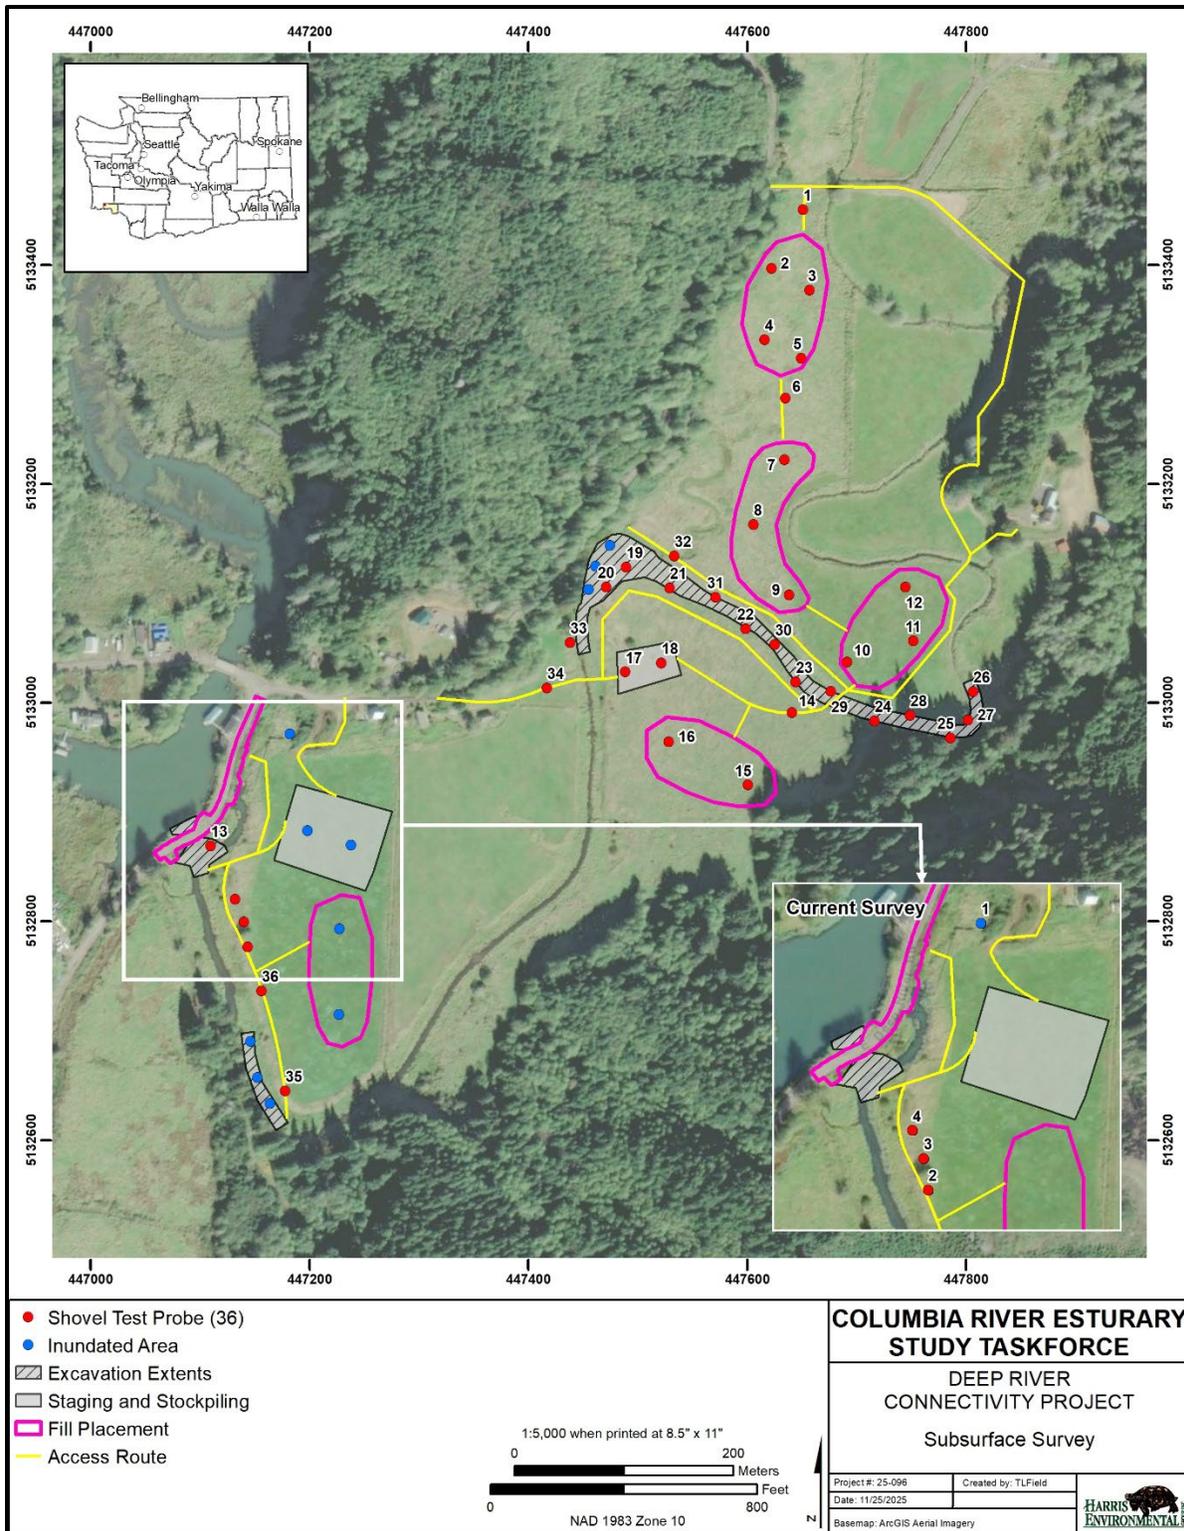
Figure 16. Aerial map showing addendum survey area and additional STPs placed in Survey Area 1 and 2.

centimeters below ground surface (cmbgs) within Survey Area 2 (Figure 16). The auger probe measured 4 inches in diameter and was excavated to a depth of 50 cmbgs or 70 centimeters below water surface (cmbws) in Survey Area 1 (Figure 16). The methods for the performance of each stage are listed below.

Harris Environmental performed subsurface investigations in Areas 1 and 2 (Figure 16). Survey Area 1 was completely inundated and so an auger investigation was performed (Figures 17-19). Three subsurface excavations were performed within Survey Area 2 (Figures 21-29). All soils observed were mottled silty clayey loam with no rock content. No cultural material was identified in any of the subsurface probes (Table 1).

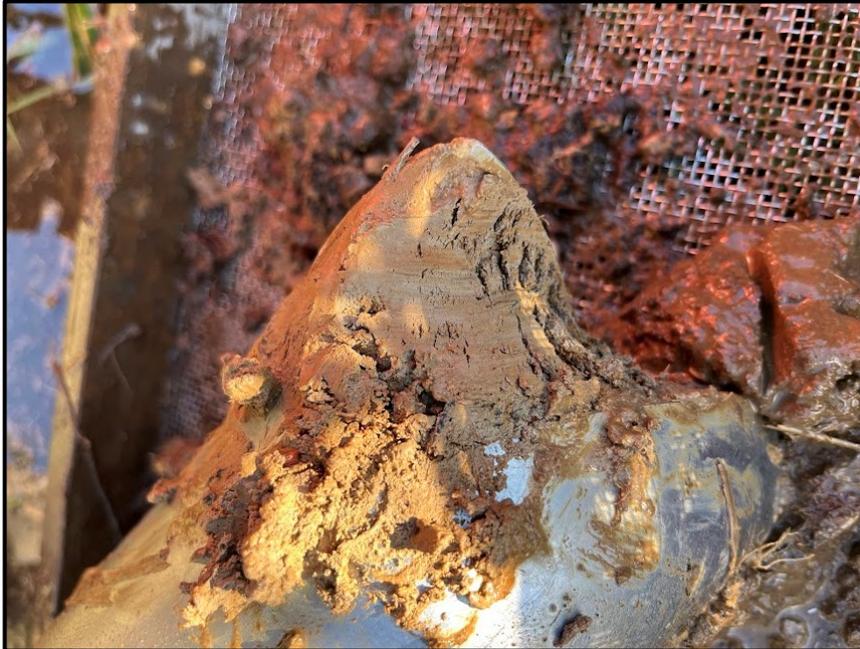
Figure 18. STP-1 representation photo of augured mottled soils to 70 cmbws.

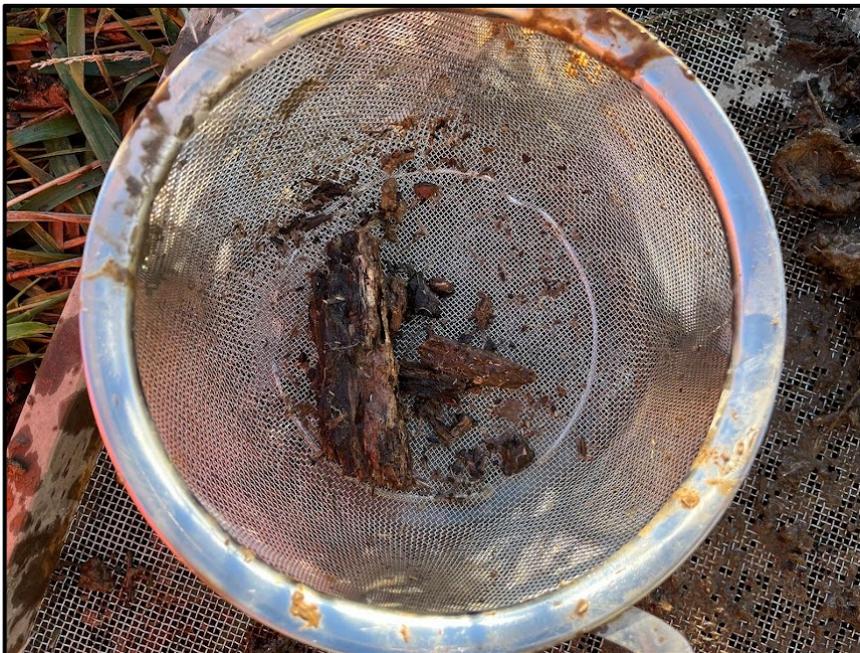
Figure 19. Photo representation of wood fragments produced from 40-70 cmbgs of STP-1.

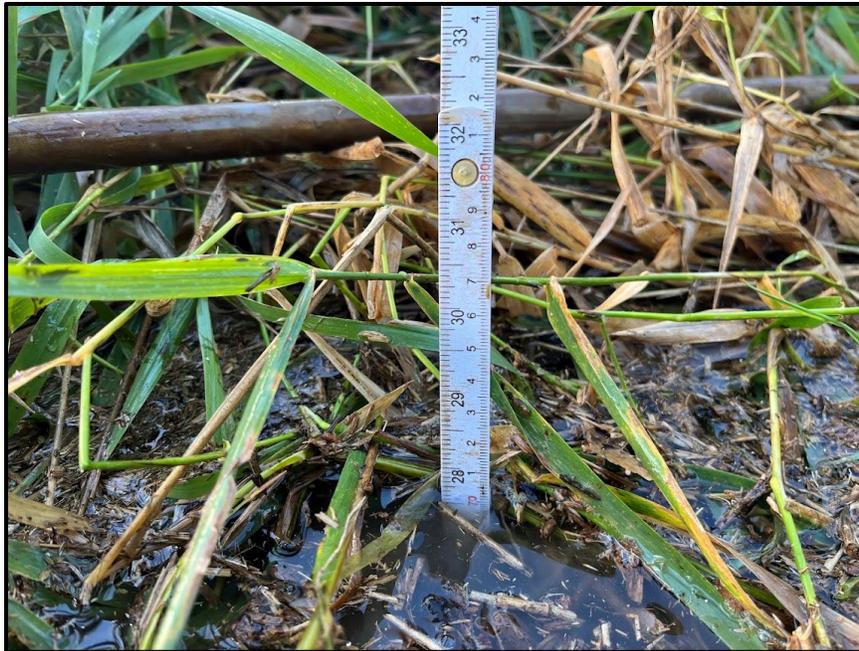
Figure 20. STP-1 augured to 50 cmbgs, beginning at 20 centimeters below water surface (cbws).

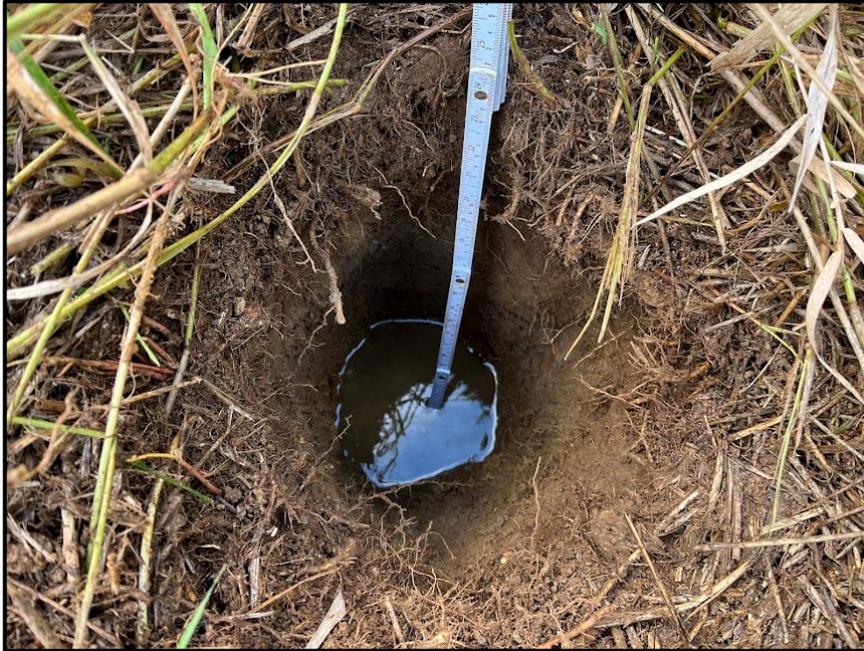
Figure 22. STP-2, terminated at 60 cmbgs, showing water table at 50 cmbgs.

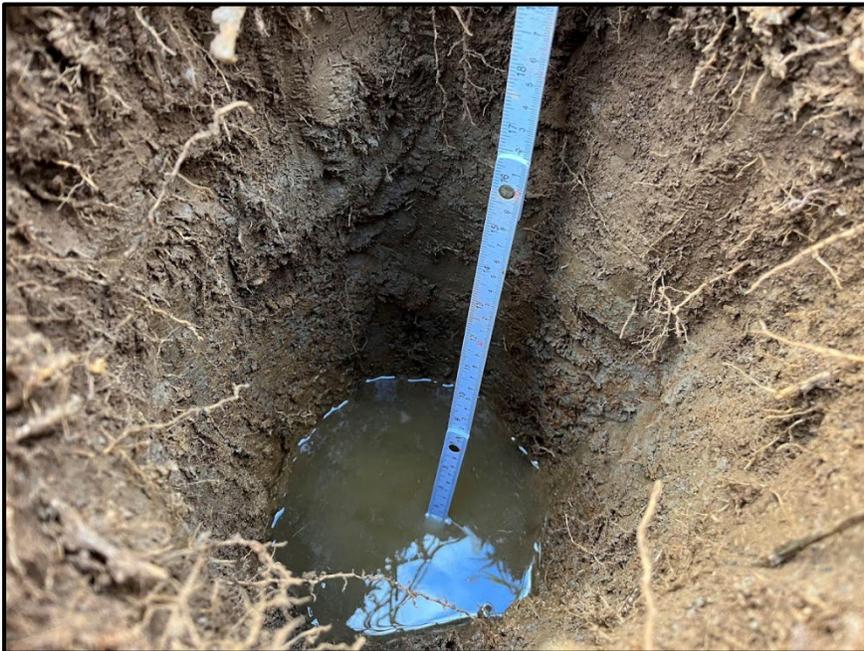
Figure 23. STP-2 terminated at 60 cmbgs, showing water table at 50 cmbgs.

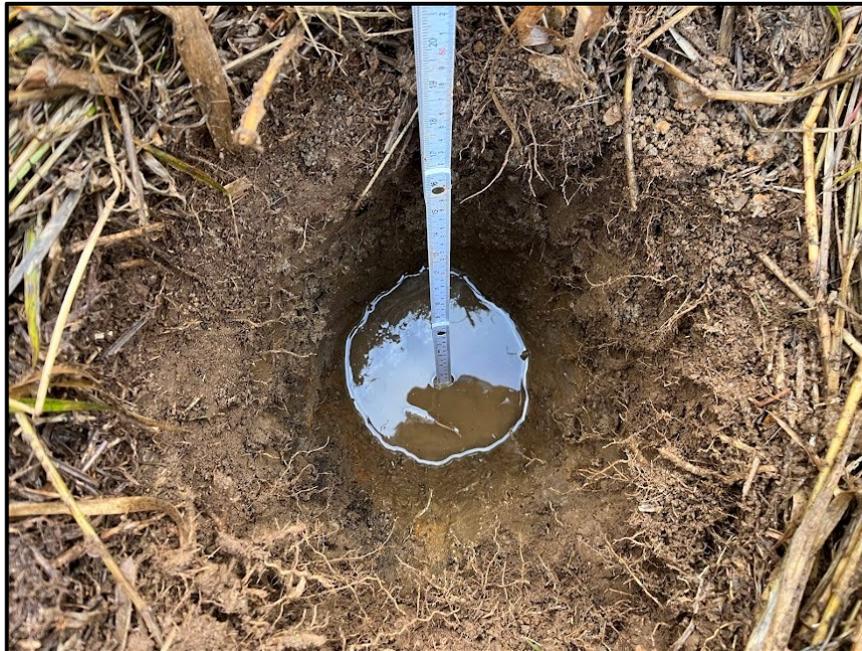
Figure 25. STP-3, terminated at 50 cmbgs, showing water table at 35 cmbgs.

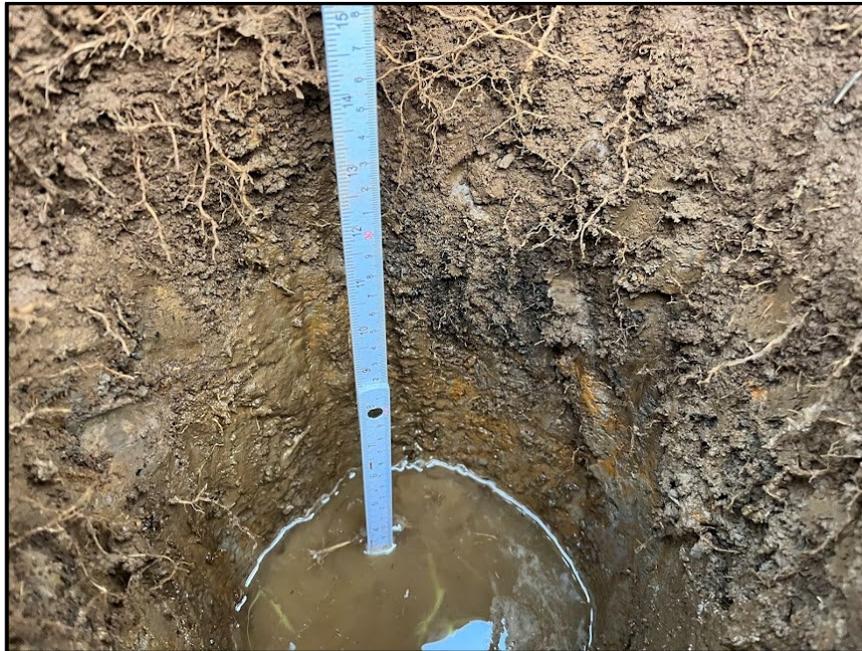
Figure 26. STP-3 southern soil profile, facing south.

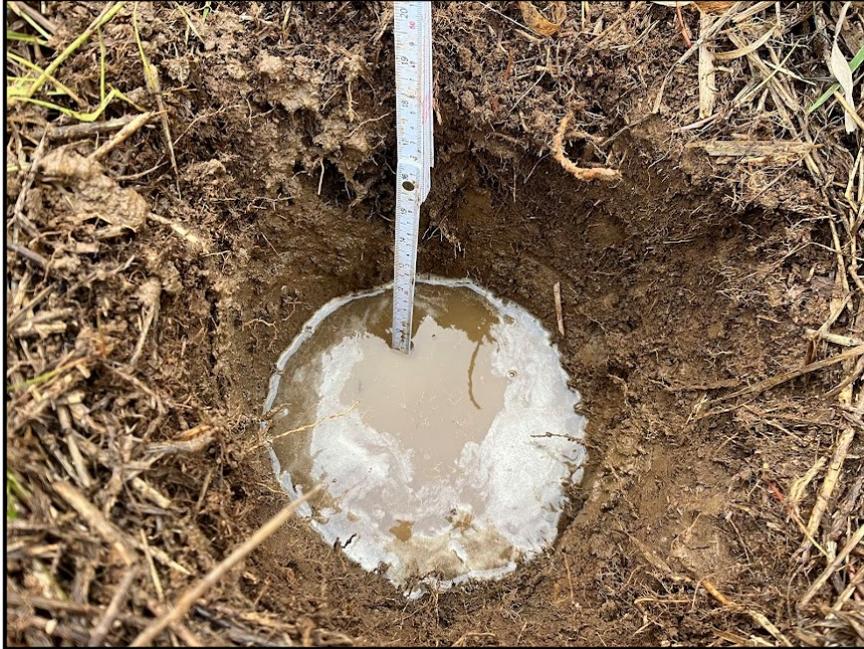
Figure 28. STP-4, terminated at 30 cmbgs, showing water table at 20 cmbgs.

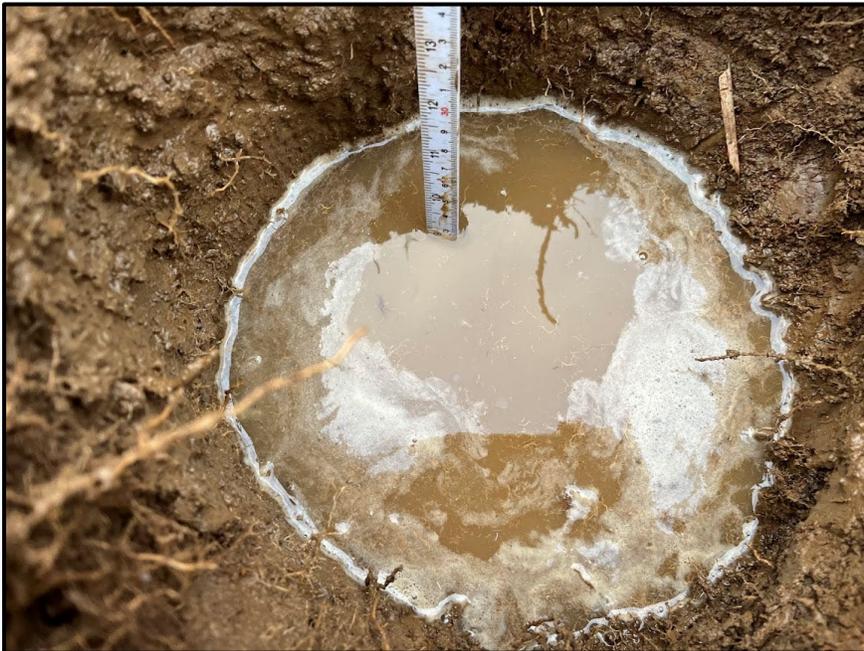
Figure 29. STP-4, terminated at 30 cmbgs.
